## **7. Damage to Buildings in Inundation Areas Induced by Tsunami**

### **7.1 Introduction**

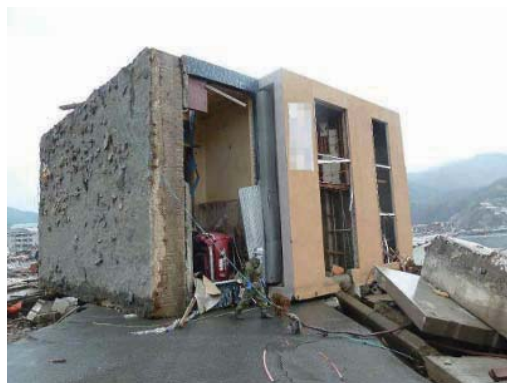
Overturning was observed in 4-story or lower buildings. In all overturned buildings, the maximum inundation depth exceeded their height. Overturning types include buildings that fell sidelong (Photo 7.2-2) and buildings that turned upside down. Most of the overturned buildings were of mat foundation. In some overturned buildings on pile foundation, piles were pulled out.

Photo 7.2-2 Overturning of a 3-story reinforced concrete building

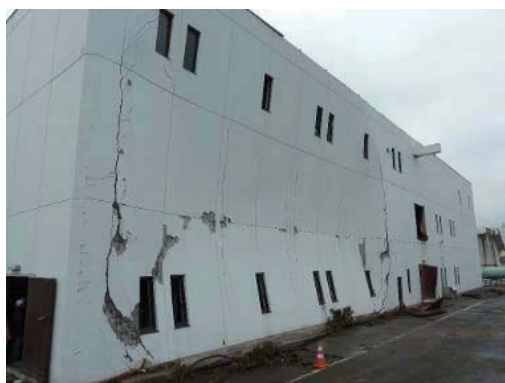
Cases that such wall reinforcement was fractured were often seen in wall members with single layer bar arrangement. In one damaged building (Photo 7.2-5), a 300 mm-thick shear wall with double layer bar arrangement and a support span of more than 10 m and without the second and third floor slabs was bent inside by tsunami wave pressure. However, a shear wall in an area (Photo 7.2-5 Back of the building, right-hand side), where there was a floor on the second story and a support span was not long in the same building, was not bent.

Photo 7.2-5 Out-of-plane fracture of reinforced concrete shear wall without floor

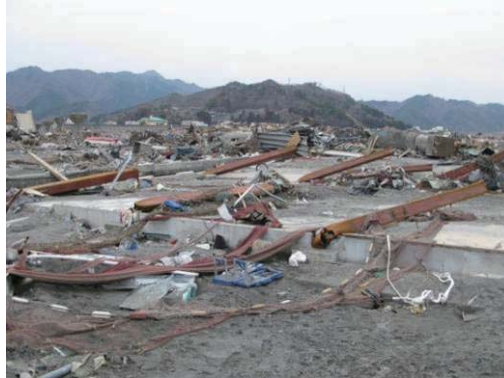
In damage cases relatively often seen that a capital connection on the first or second floor in a building was fractured, then the building was moved and washed away. When a column base has a large strength like concrete encases type or embedded type, this type of fracture is considered to occur. In one case (Photo 7.2-8), foundation in a building, and several columns on the first floor (or up to the second floor) were left on the site, and the columns fell in the same direction.

In most cases, welds between diaphragms with lower flanges and the first-floor columns were fractured and the sections of the columns were exposed. In one building, flanges of the second-floor H-shaped beams were torn. Based on the deformation states

near the column bases, it is estimated that a tensile force acted on the first-floor columns, and then the first-floor capital connections were fractured after the first floor was greatly tilted to the same extent as the inclination of the remaining columns.

Photo 7.2-8 First-floor columns falling in the same direction

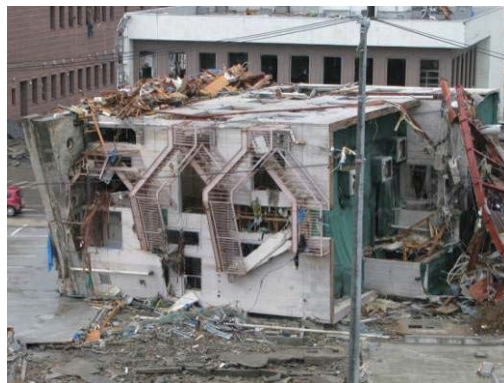
One case that a whole building including foundation was overturned, was confirmed. Most of the AAC panels of claddings were left (Photo 7.2-9).

Photo 7.2-9 Overturning of a 3-story steel building

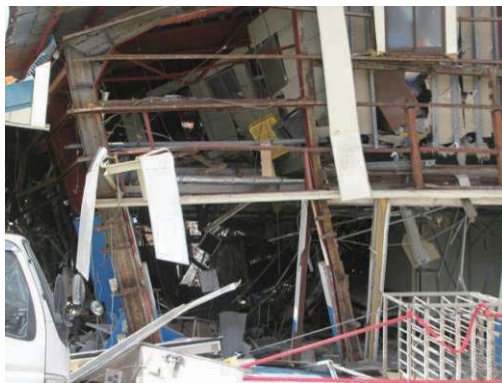
Slight tilting was often observed with remaining their skeletons in steel buildings. In one case (Photo 7.2-11), a gabled roof frame building did not collapsed despite large residual deformation.

Photo 7.2-11 Tilted gabled roof frame

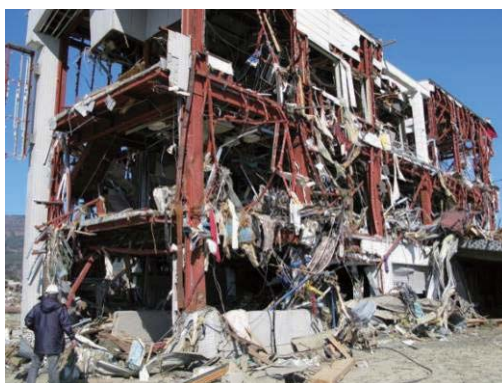
Cladding materials such as AAC panel were almost fully fractured and washed away, and then a steel frame as a skeleton was remaining. This case was often observed (Photo 7.2-12). It is considered that an external force that acted on the skeleton became small due to early washout of the cladding materials. In the remaining building, slight tilting of the skeleton, member deformation on the face affected by tsunami, and members locally damaged possibly by debris impact, were observed.

Photo 7.2-12 A remaining 3-story steel building

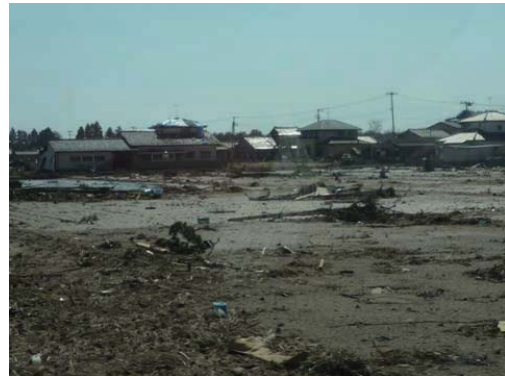
Most of wood houses near the shore were washed away. However, not all the houses were washed away. For example, many houses which were located far from the shore remained, as shown in Photo 7.4-6. The houses in the downstream of RC building remained, as shown in Photo 7.4-7.

Photo.7.4-6. Many wood houses remained.

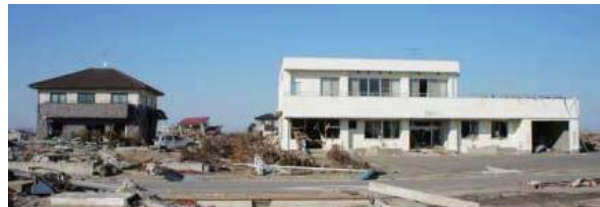
Photo.7.4-7. Wood house remained in the downstream of RC building in Arahama, Wakabayashi ward, Sendai city.

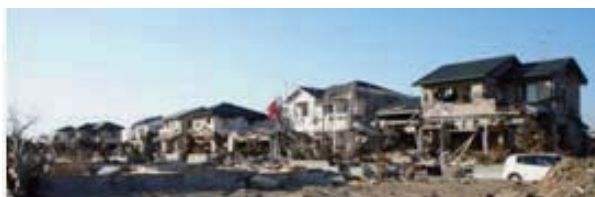
A line of wood houses remained were confirmed in Arahama-shin, Wakabayashi ward, Sendai city, as shown in Photo 7.4-8. The front survived house of the line was non-wooden. The water depth in this area was estimated at the level about 4-5 m. On the other hand, some wood houses which didn't have survived buildings in the direction where the tsunami came remained, but suffered heavy damage, as shown in Photo 7.4-9. Several such houses were confirmed in each surveyed area, and they were built by the construction methods with many metal fasteners.

Photo 7.4-8. A line of wood houses remained in Arahama-shin, Wakabayashi ward, Sendai city.

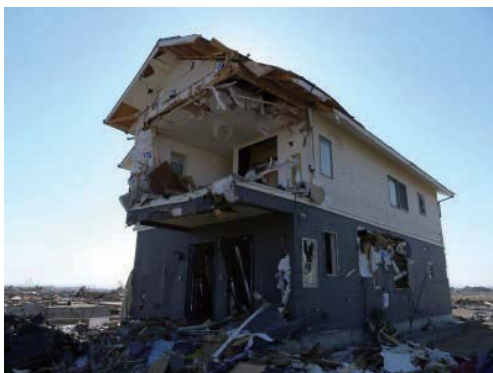
Photo 7.4-9. Remained house which didn't have survived buildings in the direction where the tsunami came in Arahama-shin, Wakabayashi ward, Sendai city.

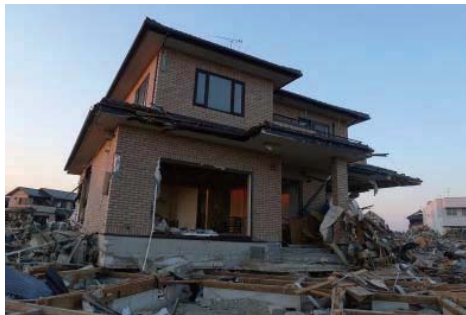
Wood buildings also suffered crushing damage due to tsunami, as shown in Fig. 7.4-2. The parts of buildings remained, for example foundation, sill, and so on, were as same as mentioned in (1). Figures in rectangles in Fig. 7.4-2 show the locations of buildings mentioned in the followings. The wood house (Photo 7.4-10:①) united with the foundation and carried away. In the original position of it, steel tube piles remained as shown in Photo 7.4-11(②). Because a temple building (Photo 7.4-12:③) and a steel-frame house (④) were damaged heavily and remained, tsunami wave force was reduced to some extent, and the neighboring wood house with store avoided being carried away, as shown in Photo 7.4-13 (⑤). It might be possible for the survived low-rise building to make wave force reduce.

Photo 7.4-10. Wood house ([1]) that was carried away with the base in Yuriage, Natori city.

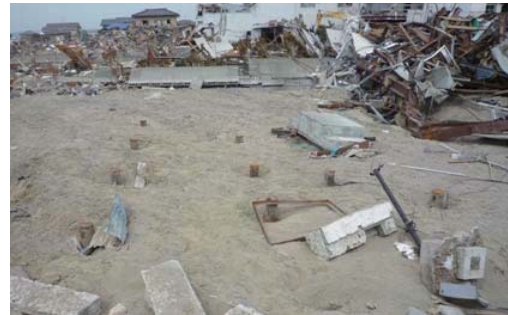
Photo 7.4-11. Steel tube pile left at the original position ([2]) of house in photo 7.4-10.

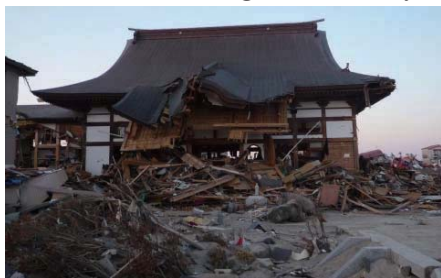
Photo 7.4-12. Heavily damaged temple ([3]) building in Yuriage, Natori city.

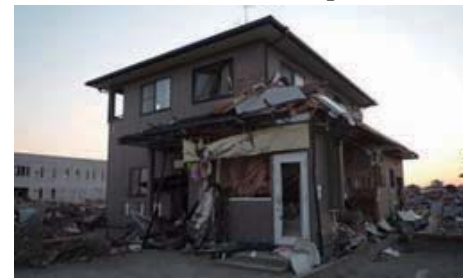
Photo 7.4-13. Wood house with store ([5]) remained in the downstream of the survived buildings in Yuriage.

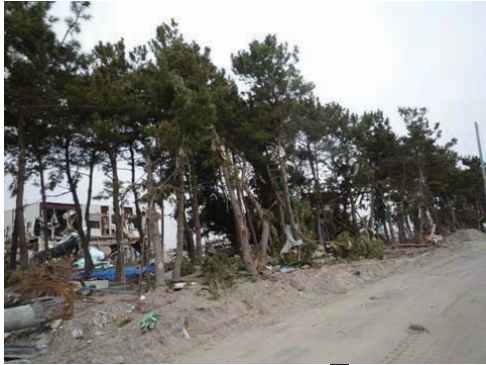
In the south east of Hiroura bridge (⑥), there was protect forest (Photo 7.4-14:⑦) of the pine trees with about 20 cm diameter at breast-height. The water depth was estimated to be about 5-6 m by the flotsam attaching to trees. A part of this protect forest fell down completely, in the downstream of this, the wood house (Photo 7.4-15:⑧) was washed away. On the other hand, in the downstream of survived protect forest, wood houses were selectively carried away and an example of the remained house was shown in Photo 7.4.16 (⑨). It seems to be generally thought that protect forest reduces wave force. However, because it cannot be thought that the strength of trees falling down continually was quite different by their location, it would be natural to think that the wave force or the speed of

Photo 7.4-14. Protect forest (7) in Yuriage, Natori city.

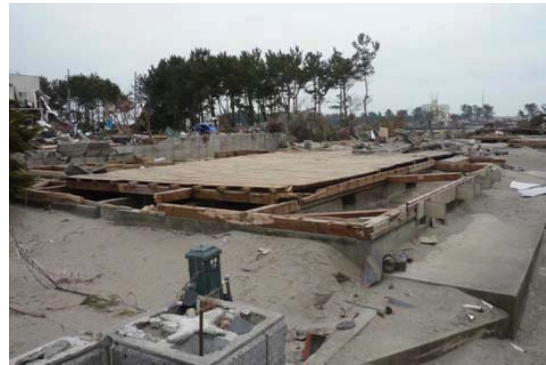
Photo 7.4-15. Fallen Protect forest and wood house (8) washed away in Yuriage, Natori city.

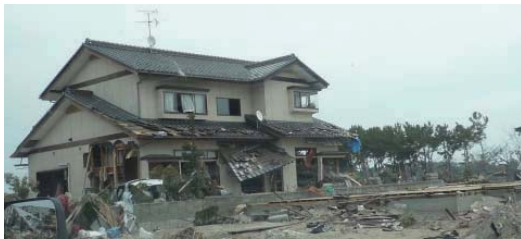
Photo 7.4-16. Protect forest and wood house (9) remained in Yuriage.

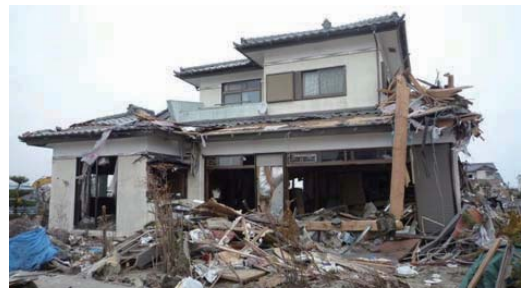
the tsunami were different by factors such as the depth of water or the submarine topography in this case. There was a house (Photo 7.4-17: [10]) remained in the area where there was no building and no protect forest existed in the direction of the wave. In addition, the relatively new Japanese conventional post and beam wood house (Photo 7.4-18 : [11]) and light frame construction house (Photo 7.4-19 : [12]) were confirmed at the location where there were no survived buildings in the direction of waves. Besides, in the downstream of the former, another Japanese conventional post and beam wood house ([13]) remained in. The water depth was estimated to be about 3.5 m in these locations.

Photo 7.4-17. Wood house (10) remained without the effect of protect forest.

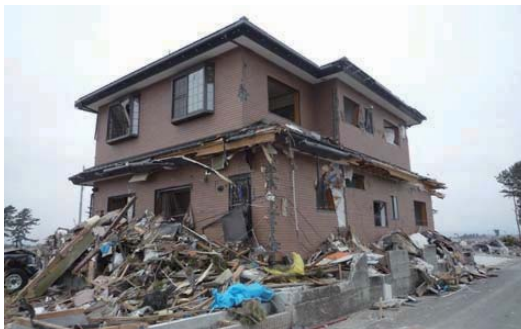
Photo 7.4-18. Japanese conventional post and beam wood house (11) remained alone.

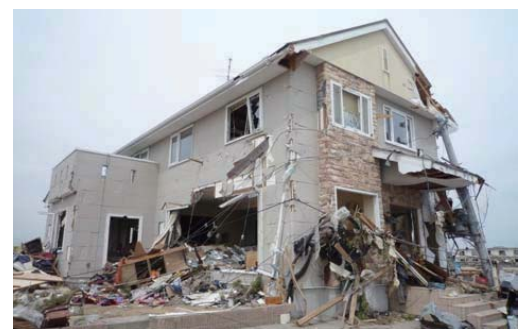
Photo 7.4-19. Light frame construction wood house (12) remained alone

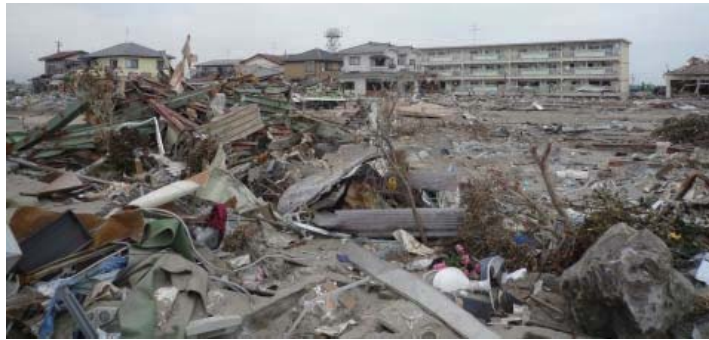
In the downstream of large RC building, houses with low structural specification (Photo 7.4-20 : [14]) also remained, as shown in Photo 7.4-20. On the other hand, in the location where was the downstream of the relatively large factory building (Photo 7.4-21 : [15]), the wood house ([16]) with relatively better structural specifications avoided being carried away, selectively.

Photo 7.4-20. Group of wood houses (14) which were not washed away in the downstream of a RC apartment house in Yuriage

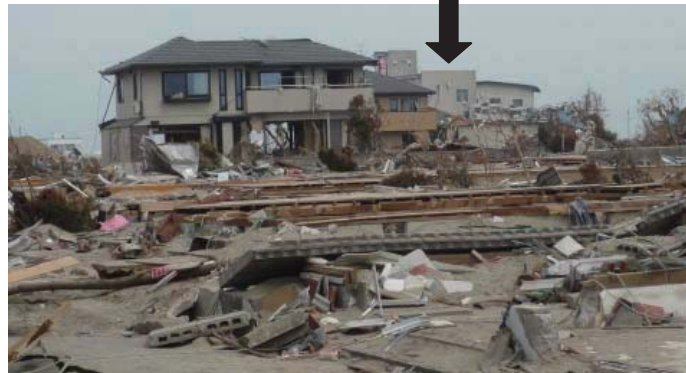
Photo 7.4-21. Wood houses (15) which were not washed away selectively in the downstream of a factory building.

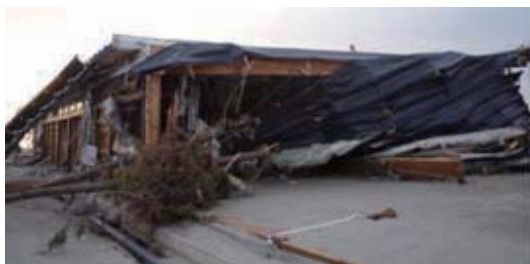
In the area between Pacific Ocean and Arahama port, remained wood buildings were Glulam frame structure (Photo 7.4-22) and a mixed structure (Photo 7.4-23) which has 1<sup>st</sup> story of RC structure and wooden 2<sup>nd</sup> story. In other cases, the part of the L-shaped wood house (Photo 7.4-24) whose part with short horizontal length in the direction of wave pressure was washed away, and another part with long horizontal length remained. It was confirmed that metal fasteners were used in the column end joints, and considered that the

Photo 7.4-22. Glulam frame structure remained in Arahama, Watari town.

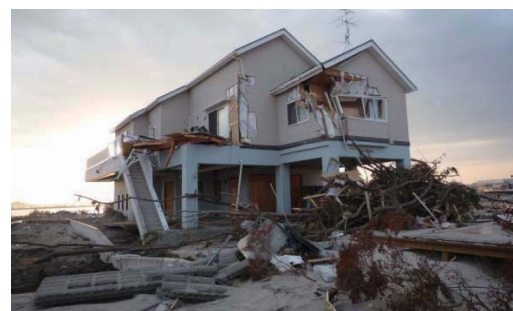
Photo 7.4-23. Mixed structure which has 1<sup>st</sup> story of RC structure and wooden 2<sup>nd</sup> story.

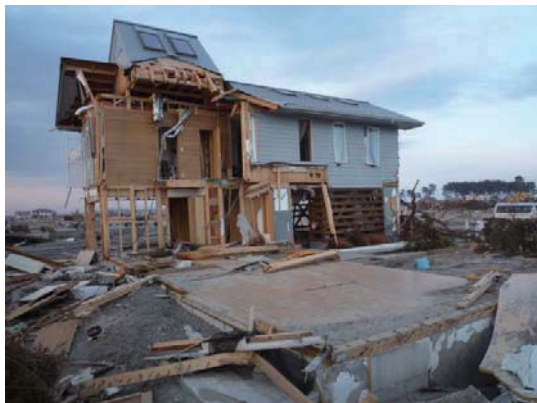
structural performance of this house was better.

Photo 7.4-24. L-shaped wood house whose part was washed away in the east of Arahama port.

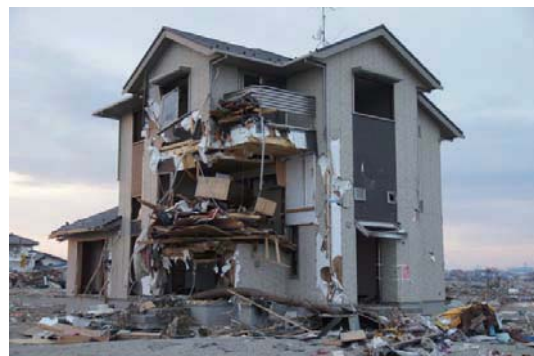
In the north area of the Arahama port, a 3-story wood house (Photo 7.4-25) remained. The reason might be that the lateral strength of 1<sup>st</sup> story in 3-story building was larger than that in 2-story building.

Photo 7.4-25. 3-story wood house remained in the north of Arahama port.

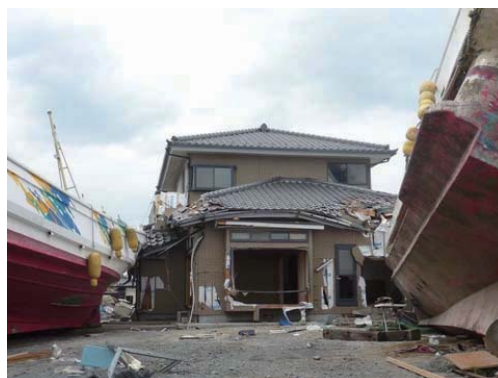
In the west area of the Arahama port, it was confirmed that the wood house (Photo 7.4-26) was crashed by two ships but remained. The reason was that the wave pressure was low and the structural performance of the house was high because the house was relatively new.

Photo 7.4-26. Wood house remained in spite of ships' crashing in the west of Arahama port.

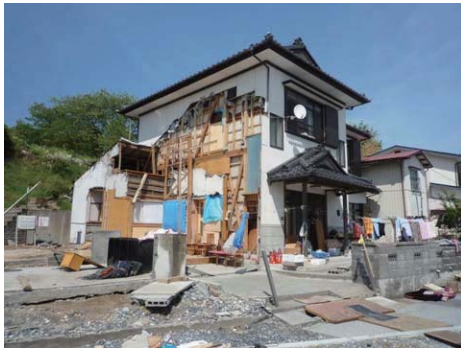
Photo 7.4-27. Wood house (1) remained under the water depth of over 7 m in Akasaki-cho, Oofunato city.

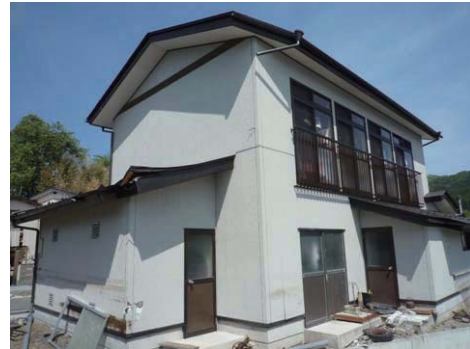
Photo 7.4-28. Wood house (3) without damage under the water depth of over 7 m in Akasaki-cho, Oofunato city.

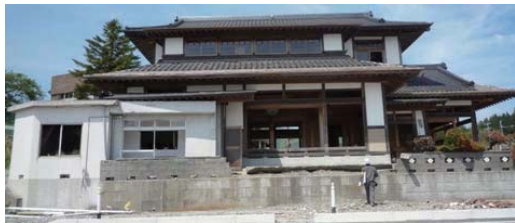
The damage in Akasaki-cho, Oofunato city was reported as an example of the tsunami damage in several surveyed slope lands. Akasaki-cho is located in the east of Oofunato bay, and is a gradual slope land. Fig. 7.4-4 shows the aerial photograph and the locations related to surveyed buildings. Similar to plain areas, many of wood houses were washed away by tsunami here in Oofunato. According to the resident of a house (Photo 7.4-27:①) located just near the shore, the height of the tsunami reached to the top of 2<sup>nd</sup> story, and the house went under the water completely. The house was damaged in a part, however it remained. The neighbouring work shed (②) whose sill came off from floor concrete moved. On the other hand, a 2-story wood house (Photo 7.4-28:③) opposite to the house (①) across the street along the sea suffered almost no damage. Two houses next to the house (①) and shed (②) remained. There is a hill in the back of them (in the north side), and there is a possibility that the hill affected the strength of the wave force caused by the tsunami. A Japanese traditional post and beam frame house (Photo 7.4-29:⑤) built on the street along the sea remained under the water depth of about 5-6 m, in spite of partial

Photo 7.4-29. Japanese traditional wood house (5) which was not carried away under about 5 m water depth in Akasaki-cho, Oofunato city.

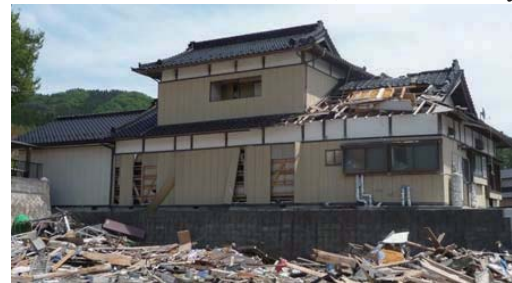
failure of walls. Close to this house, a wood house (Photo 7.4-30:6) remained under about 6 m water depth in spite of partial failure in the roof system. It was considered that this failure caused by the floating materials. There was a house (7) remained in the next, but a house which was guessed to have many hold down fasteners (8) was washed away. The house with hold down fastener may not remain by severe tsunami.

Photo 7.4-30. Wood house (6) which was not carried away in spite of damage on 1<sup>st</sup> floor roof system in Akasaki-cho, Oofunato city.

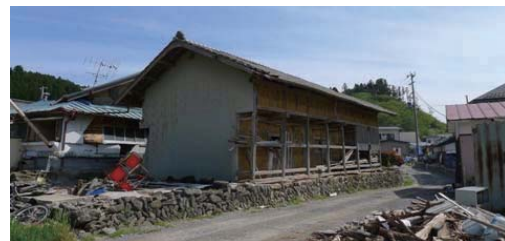
Photo 7.4-32. Survived soil warehouse (10) which seemed to have comparatively slight structural specifications in Akasaki-cho, Oofunato city.

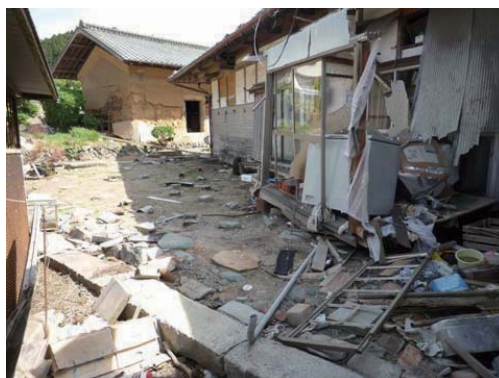
Photo 7.4-33. Survived old house (12) which rotated and moved horizontally in Akasaki-cho, Oofunato city.
