## **7. Damage to Buildings in Inundation Areas Induced by Tsunami**

### **7.1 Introduction**

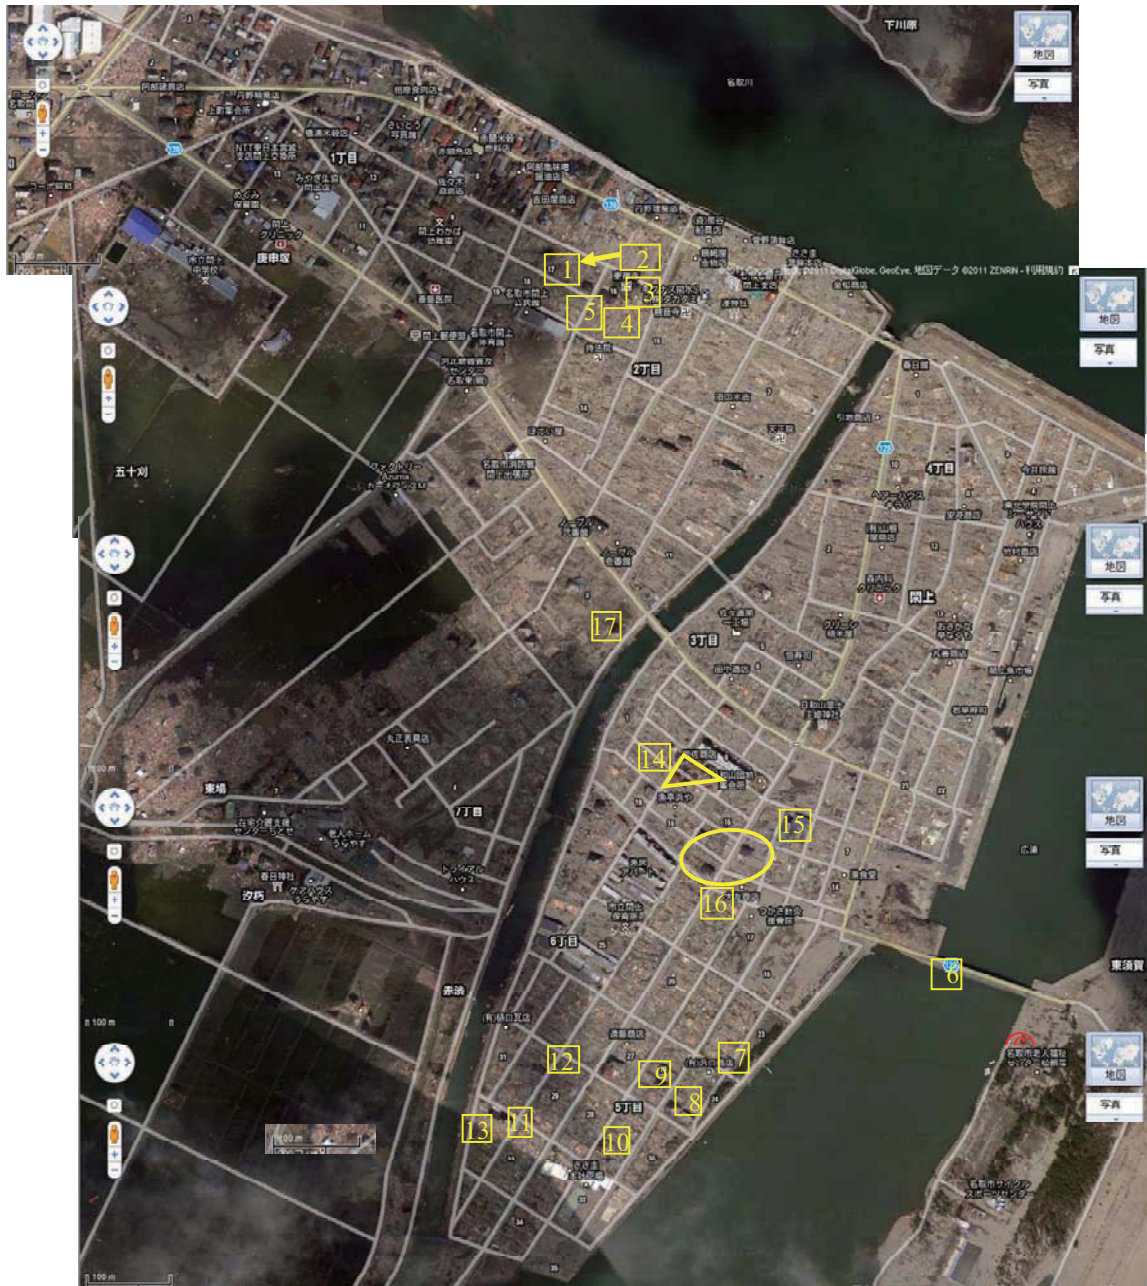
Fig. 7.4-2. Aerial photograph and the location related to surveyed buildings in Yuriage, Natori city.

Wood buildings also suffered crushing damage due to tsunami, as shown in Fig. 7.4-2. The parts of buildings remained, for example foundation, sill, and so on, were as same as mentioned in (1). Figures in rectangles in Fig. 7.4-2 show the locations of buildings mentioned in the followings. The wood house (Photo 7.4-10:①) united with the foundation and carried away. In the original position of it, steel tube piles remained as shown in Photo 7.4-11(②). Because a temple building (Photo 7.4-12:③) and a steel-frame house (④) were damaged heavily and remained, tsunami wave force was reduced to some extent, and the neighboring wood house with store avoided being carried away, as shown in Photo 7.4-13 (⑤). It might be possible for the survived low-rise building to make wave force reduce.

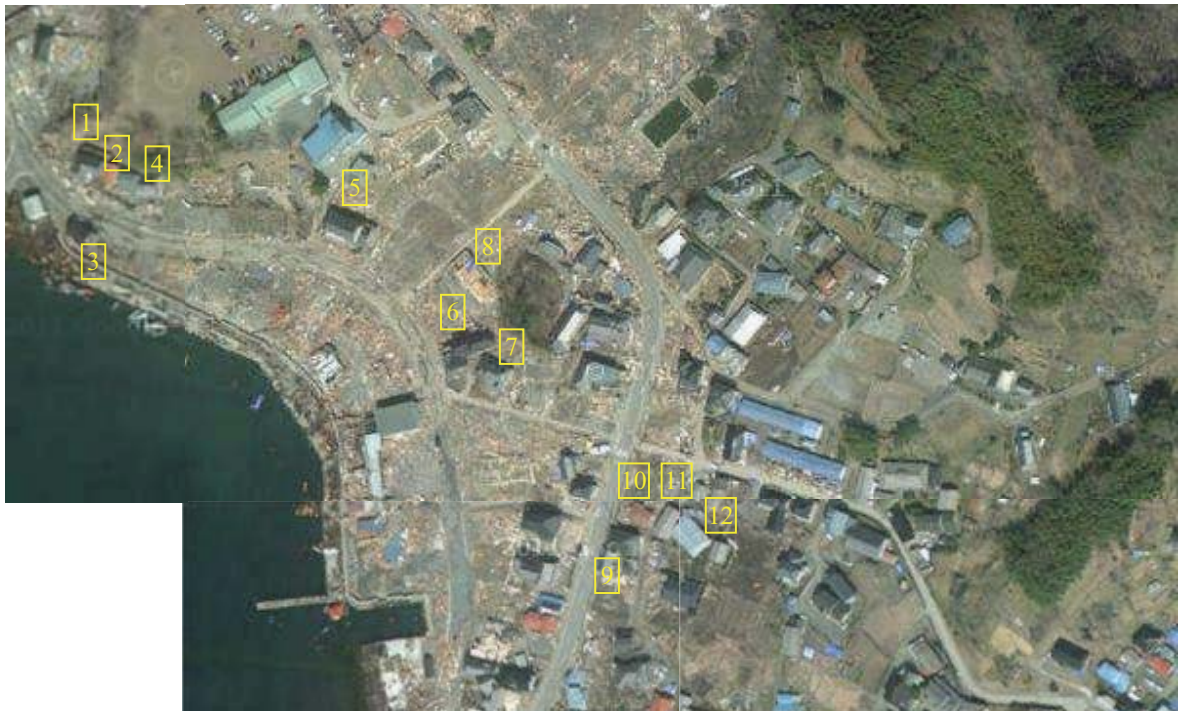
Fig. 7.4-4. Aerial photograph and the locations related to surveyed buildings in Akasaki-cho, Oofunato city.

The damage in Akasaki-cho, Oofunato city was reported as an example of the tsunami damage in several surveyed slope lands. Akasaki-cho is located in the east of Oofunato bay, and is a gradual slope land. Fig. 7.4-4 shows the aerial photograph and the locations related to surveyed buildings. Similar to plain areas, many of wood houses were washed away by tsunami here in Oofunato. According to the resident of a house (Photo 7.4-27:①) located just near the shore, the height of the tsunami reached to the top of 2<sup>nd</sup> story, and the house went under the water completely. The house was damaged in a part, however it remained. The neighbouring work shed (②) whose sill came off from floor concrete moved. On the other hand, a 2-story wood house (Photo 7.4-28:③) opposite to the house (①) across the street along the sea suffered almost no damage. Two houses next to the house (①) and shed (②) remained. There is a hill in the back of them (in the north side), and there is a possibility that the hill affected the strength of the wave force caused by the tsunami. A Japanese traditional post and beam frame house (Photo 7.4-29:⑤) built on the street along the sea remained under the water depth of about 5-6 m, in spite of partial

failure of walls. Close to this house, a wood house (Photo 7.4-30:6) remained under about 6 m water depth in spite of partial failure in the roof system. It was considered that this failure caused by the floating materials. There was a house (7) remained in the next, but a house which was guessed to have many hold down fasteners (8) was washed away. The house with hold down fastener may not remain by severe tsunami.

At the location where we went up the slope land from these houses, a light steel-frame house (9) remained in under the about 5 m water depth. In the next of this house, the 1-story old wood house (Photo 7.4-31:10) whose structural specification was not so good, but the anchor bolts were installed remained. In addition, a warehouse with mud walls (Photo 7.4-32:11) was remained and an old wood house without anchors (Photo 7.4-33:12) turned and moved horizontally. Because the wood house under about 5 m water depth were almost washed away in plain areas, it might be possible for the slope land to make lateral force caused by tsunami a little smaller.
